DEPARTMENT OF TRANSPORTATION

Contract #: 04-0120F4Cty: SF/ALA Rte: 80 PM: 13.2/13.9File #: 69.28**WELDING INSPECTION REPORT****Resident Engineer:**Pursell, Gary**Address:** 333 Burma Road**City:** Oakland, CA 94607**Report No:** WIR-013080**Date Inspected:** 27-Mar-2010**Project Name:** SAS Superstructure**OSM Arrival Time:** 700**Prime Contractor:** American Bridge/Fluor Enterprises, a JV**OSM Departure Time:** 1900**Contractor:** Zhenhua Port Machinery Company, Ltd (ZPMC), Changxing Island **Location:** Shanghai, China**CWI Name:** Mr.Wuzhi Cheng**CWI Present:** Yes No**Inspected CWI report:** Yes No N/A**Rod Oven in Use:** Yes No N/A**Electrode to specification:** Yes No N/A**Weld Procedures Followed:** Yes No N/A**Qualified Welders:** Yes No N/A**Verified Joint Fit-up:** Yes No N/A**Approved Drawings:** Yes No N/A**Approved WPS:** Yes No N/A**Delayed / Cancelled:** Yes No N/A**Bridge No:** 34-0006**Component:** Orthotropic Box Girder(OBG)**Summary of Items Observed:**

OBG TRIAL ASSEMBLY

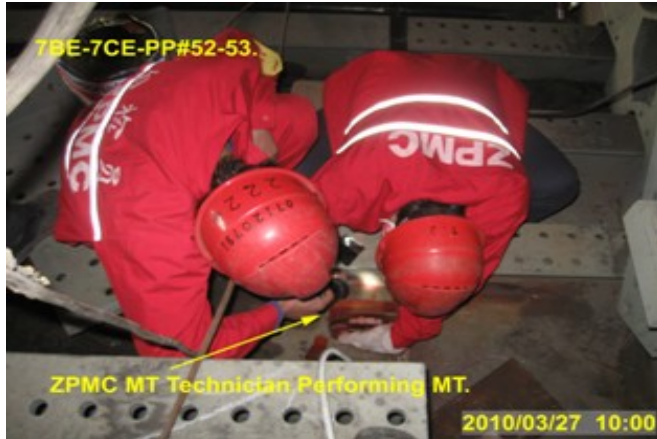
SEGMENT: 7BE-7CE - PP#52-53, Bottom panel.

This QA Inspector observed ZPMC MT Technician Mr. Xu Hai was performing Magnetic Particle Testing (MT) for Bottom panel T Rib Holdback fillet welds at SEGMENT: 7BE-7CE - PP#52-53. The attached photographs provide additional detail.

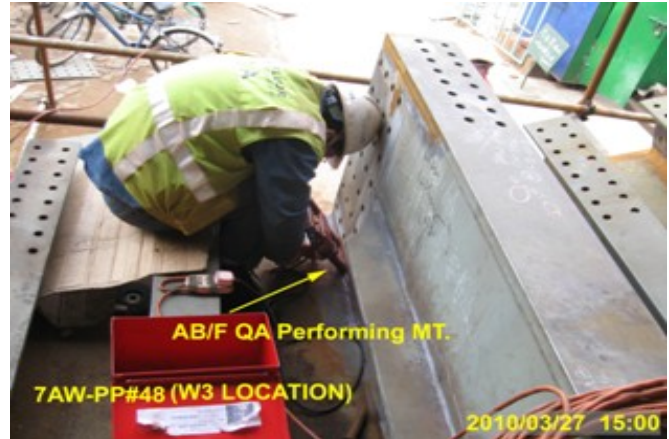
SEGMENT: 7AW, PP#48, Counter Weight side.

This QA Inspector observed American Bridge/Fluor (AB/F) QA Inspector Mr. Shi Diao was performing Magnetic Particle Testing (MT) for Longitudinal Diaphragm Holdback fillet welds at SEGMENT: 7AW PP#48, W3 Location.
